Manhole Inspection Summary

Manhole # S21AA_055MH

Insp Date: **9/7/07 9:22 AM**

Location Address: **901 BRUCE ST**

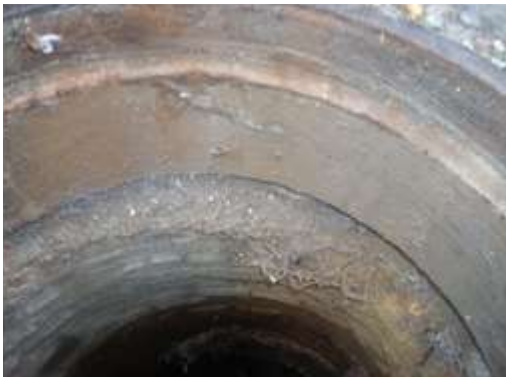
Defect 5

Offset: **2** (in.)

FRAME OFFSET

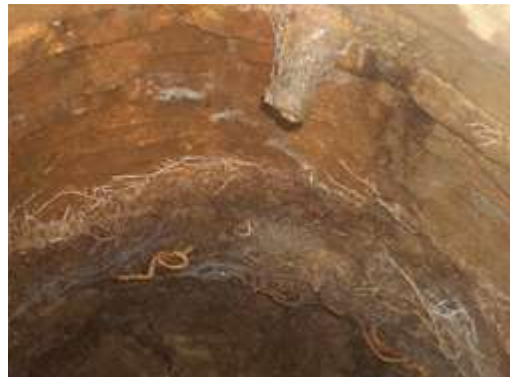
Defect 4

Condition: ☐ Sound ☐ Cracked ☒ **Root Intrusion** ☐ Loose Brick ☒ **Deteriorated**

Condition: ☐ Sound ☐ Cracked ☒ **Root Intrusion** ☐ Loose Brick ☐ Deteriorated

ROOT INTRUSION OF THE CORBEL
AND BARREL WALL

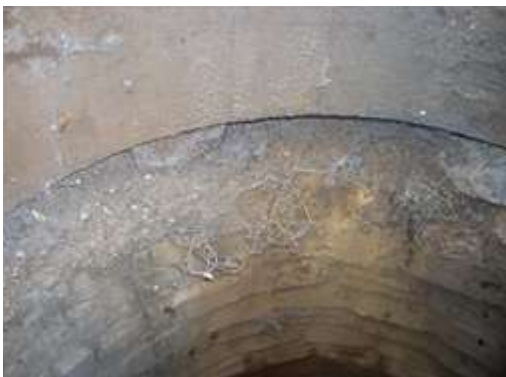
Defect 3

ROOT INTRUSION OF THE CORBEL
JOINT

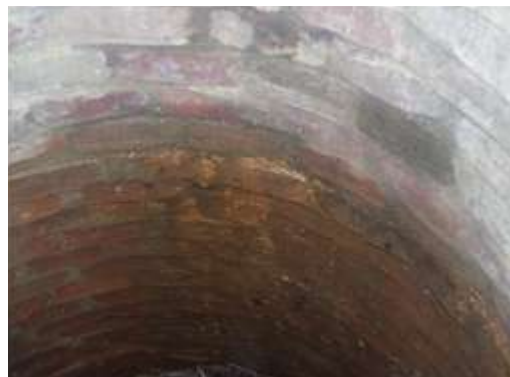
Defect 2

Infiltration: ☐ None ☐ Joint ☐ Cracks ☐ Mortar ☐ Roots ☒ **Wall**

INFILTRATION OF THE CORBEL WALL

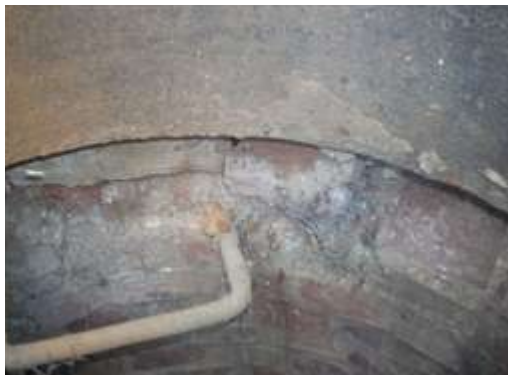
Defect 1

DETERIORATED CORBEL

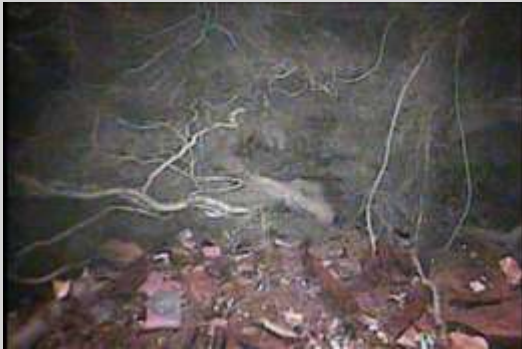
12 O'Clock Outflow

Comments **pipe is almost totally blocked by roots**

8 in. Circular Gravity Sewer
Pipe Out @ 12 O'Clock

Deposits: ☐ None ☐ Mud ☐ Sludge ☒ **Debris** ☐ Grease

Silt Depth: **7** (in.) Deposits Extent: **Heavy**
